# Notice of Proposed Amendment 2025-01 (A)

## Take-off performance parameters and position errors — large aeroplanes

RMT.0741

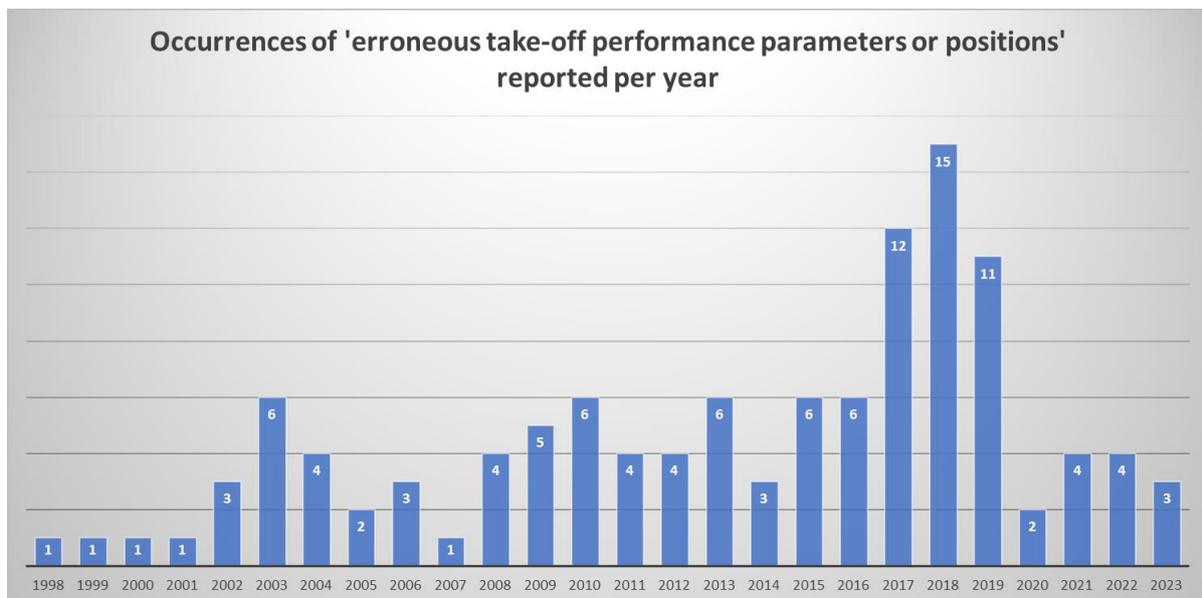
Figure 1. Yearly distribution of the reported occurrences (overall)

EASA analysed the reported occurrences (accidents, serious incidents, incidents) involving the causal factors described in Section 2.1.1.1 (take-off performance parameters and position errors). The analysis gathered 118 occurrences worldwide between 1998 and 2023 (Figure 1) that were investigated by safety investigation authorities.

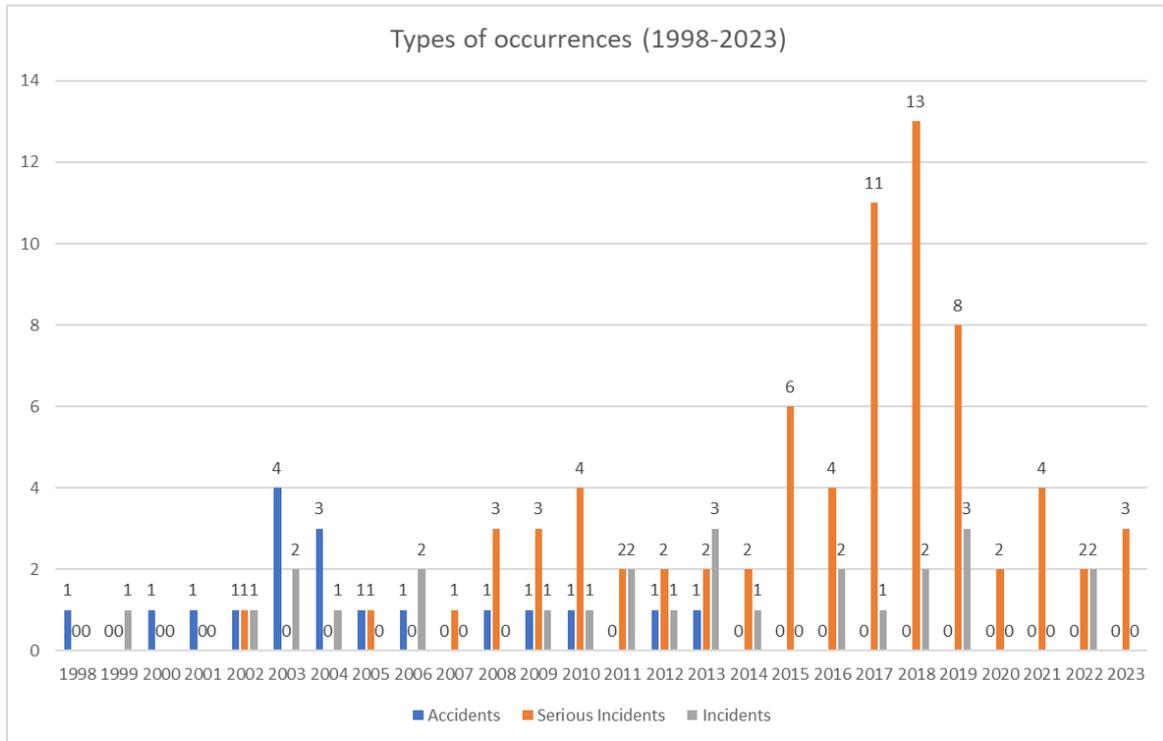
Figure 2. Yearly distribution of the reported occurrences (by type of occurrence)

The breakdown of the 118 occurrences is as follows: 18 accidents (including 5 fatal), 74 serious incidents and 26 incidents (Figure 2).

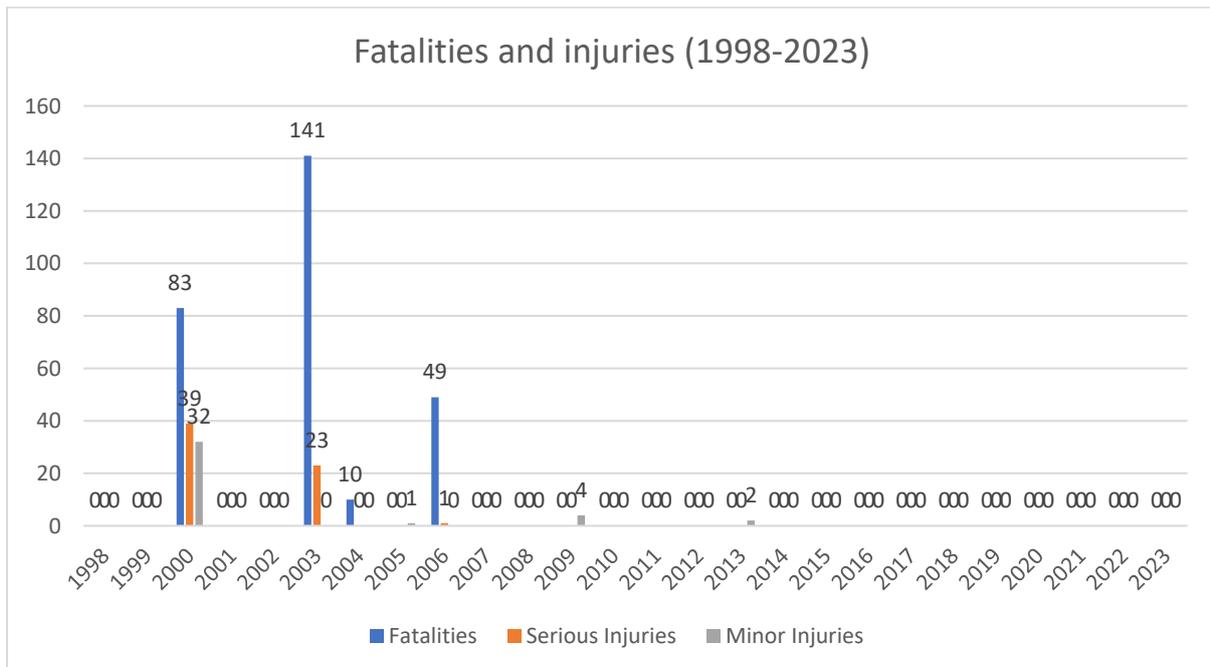
Figure 3. Yearly distribution of fatalities and injuries

These occurrences resulted in a total of 283 fatalities, 63 serious injuries and 39 minor injuries, distributed as shown in Figure 3.

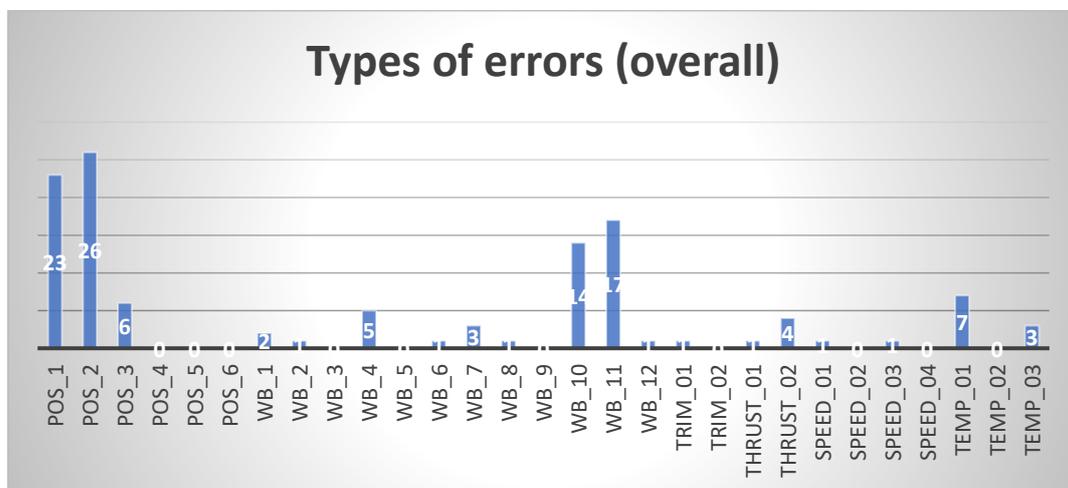
Figure 5. Overall distribution of the various types of errors

Figures 5–9 show the distribution of the types of errors.

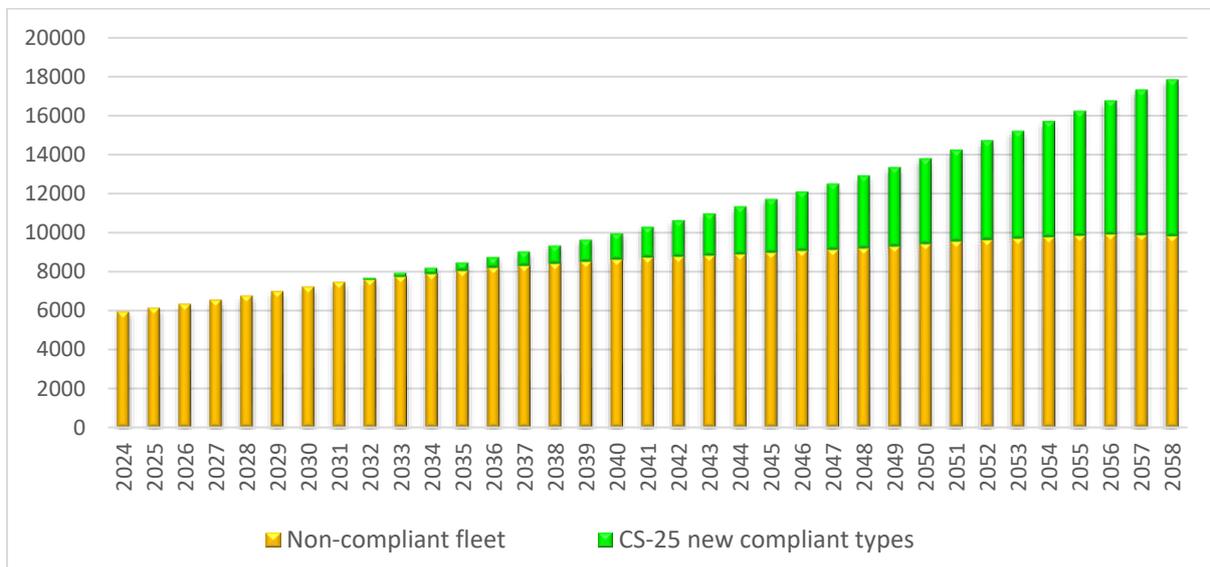
**Figure 11. CS-25 large aeroplane fleet evolution (EASA Member States) — CS-25**

Figure 11 illustrates the fleet evolution when mandating a TOPMS via CS-25 new certification specifications. A mandate for Part-26 is not provided in this scenario, resulting in a high share of non-compliant aeroplanes in the CS-25 fleet.

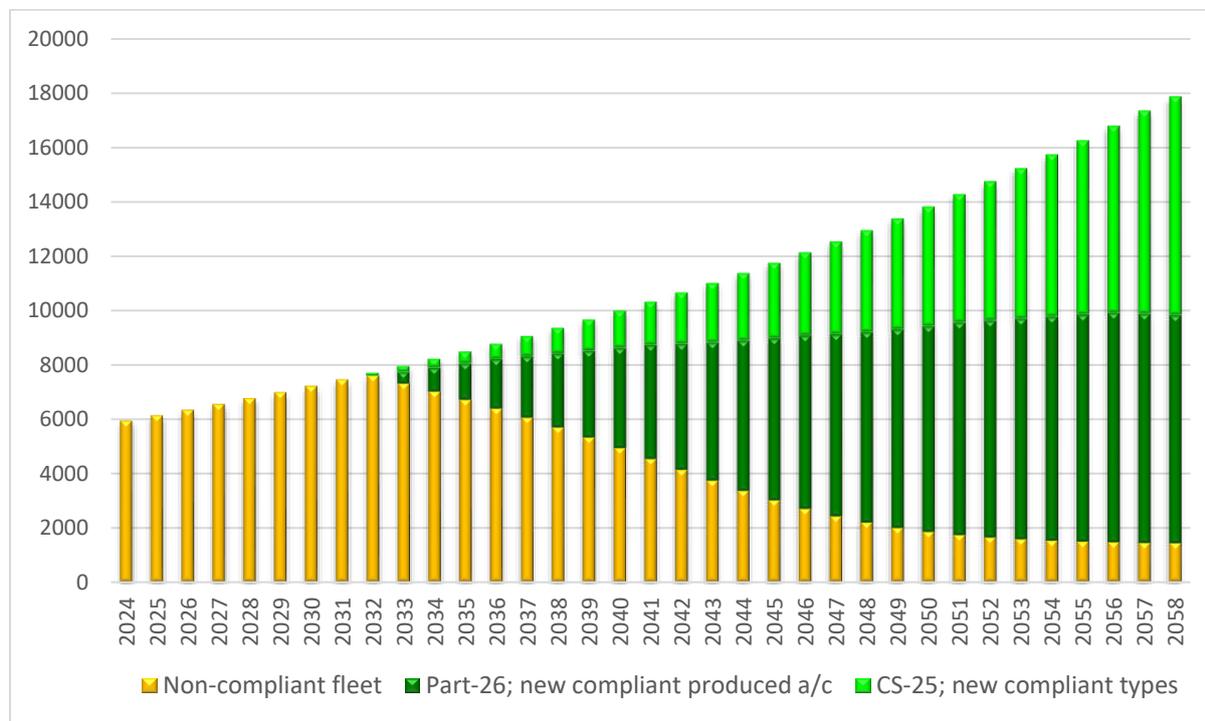
**Figure 12. CS-25 large aeroplane fleet evolution (EASA Member States) — CS-25 and Part-26**

The orange bars in Figure 12 show the current fleet size that is not yet equipped with a TOPMS. As per the assumptions made to model the fleet evolution (i.e. annual growth rate, annual retirement rate) the light green bars show the aeroplanes entering the market (new TC) that are equipped with a TOPMS. The dark green bars show new deliveries of aeroplanes equipped with a TOPMS per the Part-26 mandate.
